Large Bolted Joints

Progress Report No. 1

STATIC TENSION TESTS OF BOLTED JOINTS

Fritz Engineering Laboratory Report No. 271.1

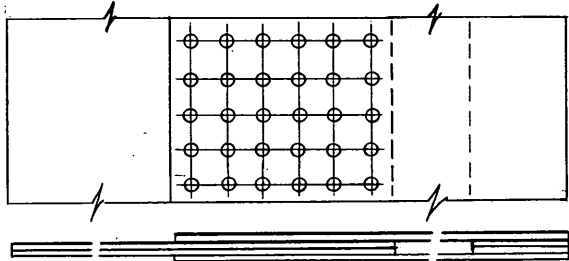
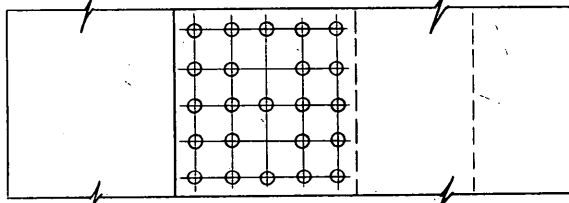
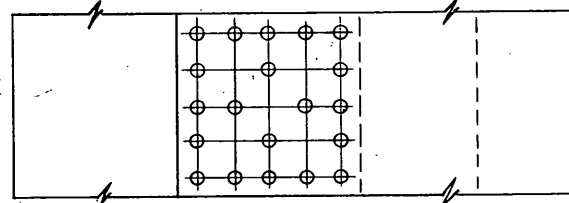
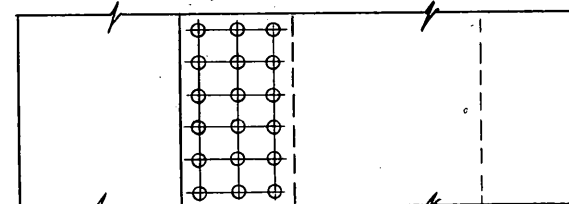
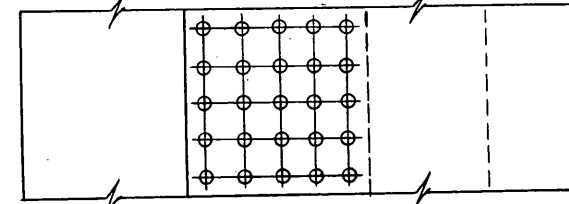
TABLE 2

<p>4-Pls. 18" x 1" x 7'1" 2-Pls. 18" x 1" x 2'4" (Fill at grip) 30 A325 Bolts 7/8" diameter</p>	$\frac{1.00}{0.74}$	3 5/8"	3 1/2"
B2	Same as B1 except 5 rows-25 bolts	1.00/0.89	"	"
B3	Same as B1 except 4 rows-20 bolts	1.00/1.11	"	"
B4

<p>23-A325 Bolts 7/8" diameter</p>	$\frac{1.00}{0.97}$	"	"
B5

<p>20-A325 Bolts 7/8" diameter</p>	$\frac{1.00}{1.11}$	"	"
B6

<p>18-A325 Bolts 7/8" diameter</p>	$\frac{1.00}{1.14}$	3" g/d*= 3.20	"
BR2

<p>25-A141 Rivets 7/8" diameter</p>	$\frac{1.00}{0.89}$	3 5/8" g/d*= 3.87	"

The "B Series" of specimens, consisting of six bolted joints using 7/8" high strength bolts, and one comparison riveted joint using 7/8" structural rivets, is shown in Table 2. Basically, the specimens were fabricated as half of a butt joint or what might be called a "double lap" joint, consisting of an inner or main plate made up of two pieces of 18" x 1" x 7'-1" steel plate and two outer or lap plates which were each 18" x 1" x 7'-1" steel plate. Plate of constant thickness was used in order to eliminate as much as possible any variation in material properties. In order to make efficient use of the available material, only three joints were fabricated at first while the remaining material was held in storage pending the results of testing the first three.

The first three joints (B1, B2, B3) were designed on the basis of a progressively increasing T/S ratio, beginning with the present specification relation of $T/S = 1.00/0.75$. On that basis, Joint B1 required 30 bolts for a T/S of 1.00/0.74. It was decided to use a pattern of five longitudinal lines at a gage of 3 5/8" and six transverse rows at a pitch of 3 1/2". These dimensions produced a compact bolt group and permitted easy variation of the T/S ratio with out major pattern changes. Joint B2 was similar to B1, but omitted one transverse row of bolts so that there were only 25 bolts used, thus increasing the T/S ratio to 1.00/0.89. Similarly, Joint B3 omitted still another transverse row of bolts to obtain a pattern of 20 bolts with a T/S of 1.00/1.11.

The test results of the first three specimens provided the basis for designing joints B4, B5, B6 and BR2. It was decided to explore further in the region of $T/S = 1.00/1.00$. Joint B4 was designed for a T/S of $1.00/0.97$ by omitting two bolts from the middle row of a 5×5 pattern similar to that of B2. The modification of the original close pattern for B4 lead to the design of B5 which used a still more "open" pattern, but reverted to the same T/S as in B3 ($1.00/1.11$). This was accomplished by using 20 bolts in a 5×5 pattern having two bolts missing in each of the second and fourth rows and one bolt missing in the middle row. Joint B6 increased the T/S ratio to $1.00/1.15$ in a more compact 6×3 pattern (six lines and three transverse rows). This reduced the gage to 3" but the pitch remained at the original $3 \frac{1}{2}$ " value. The comparison riveted joint, BR2, was designed exactly like the bolted joint B2 so that a direct comparison of rivet strength to bolt strength might be made at a shear stress greater than presently allowed by specifications.

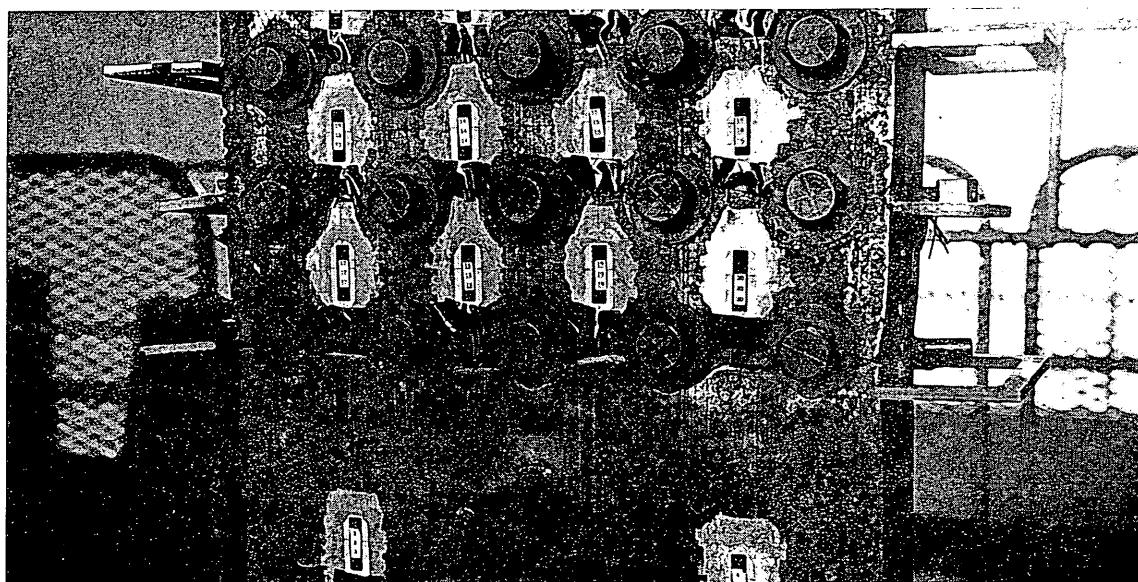
FIG. 15. TENSILE FAILURE OF JOINT B2

66.3 ksi by approximately 10%. The ruptured joint is shown in Fig 15.
